**BLACKSTONE RIVER BASIN  
WORCESTER, MASSACHUSETTS**

**CURTIS PONDS DAM  
MA 00140**

**PHASE I INSPECTION REPORT  
NATIONAL DAM INSPECTION PROGRAM**

**OCTOBER 1978**

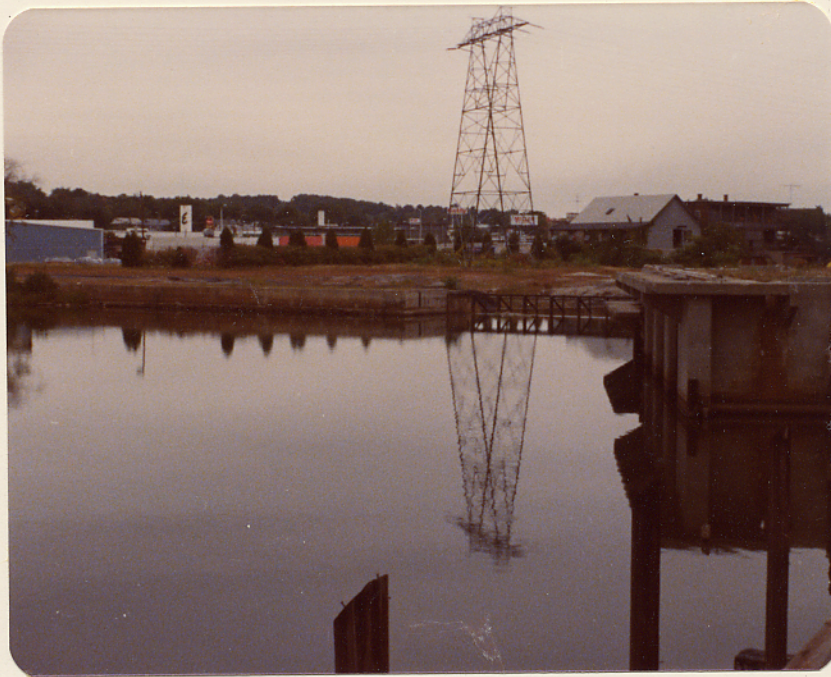
**VIEW OF UPSTREAM FACE OF DAM**

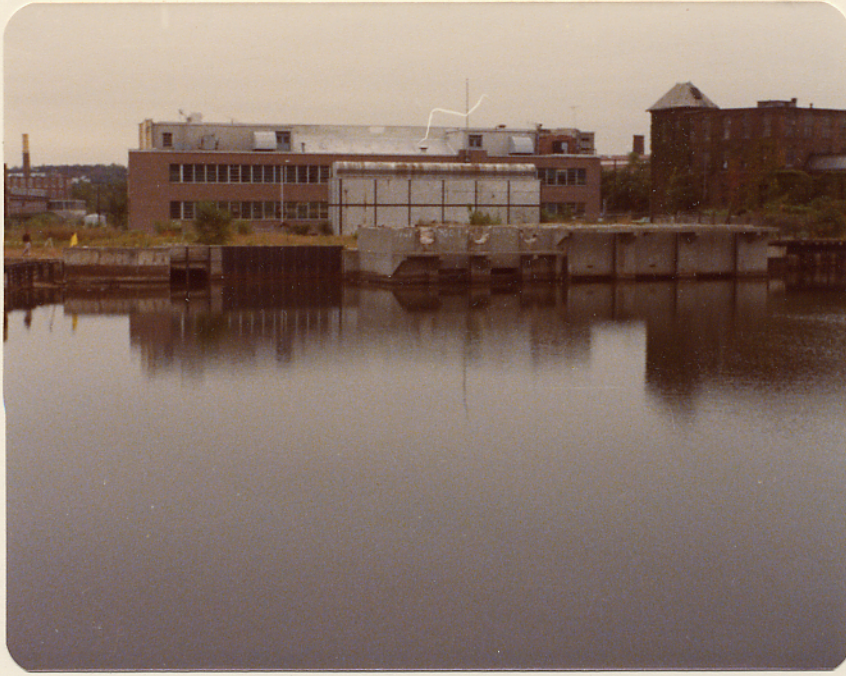
There is no operable outlet at this dam. The remnants of a gate house, about 12 intake gates and a flume to return water to the pond are located just upstream of the spillway. These structures have not been used for about 10 years. Some are missing slide gates, some are filled with debris from building demolition, and all are missing operating mechanisms.

**NO. 1 VIEW OF ABANDONED INTAKE STRUCTURES**

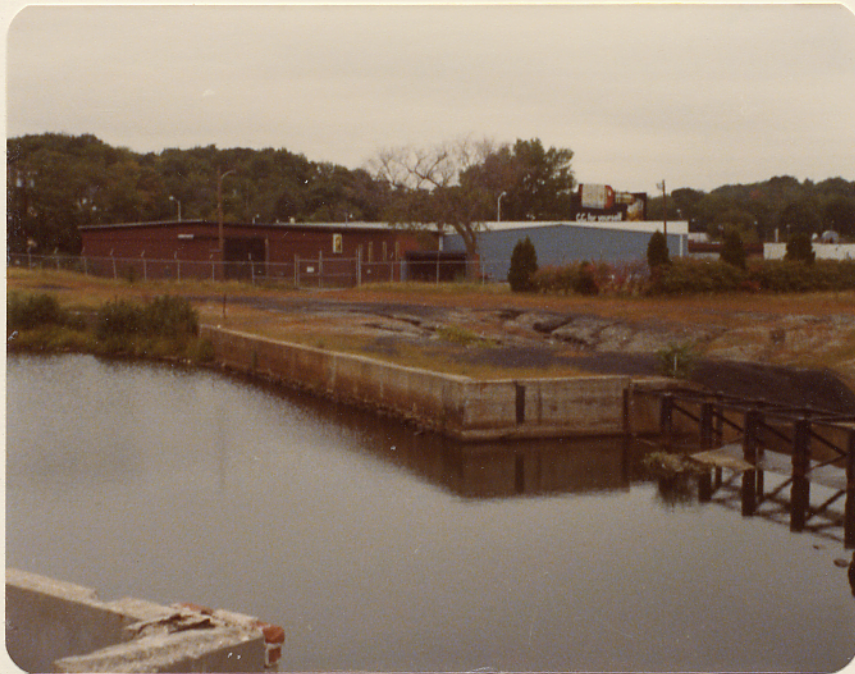
**NO. 2 VIEW OF SPILLWAY AND NORTH ABUTMENT**

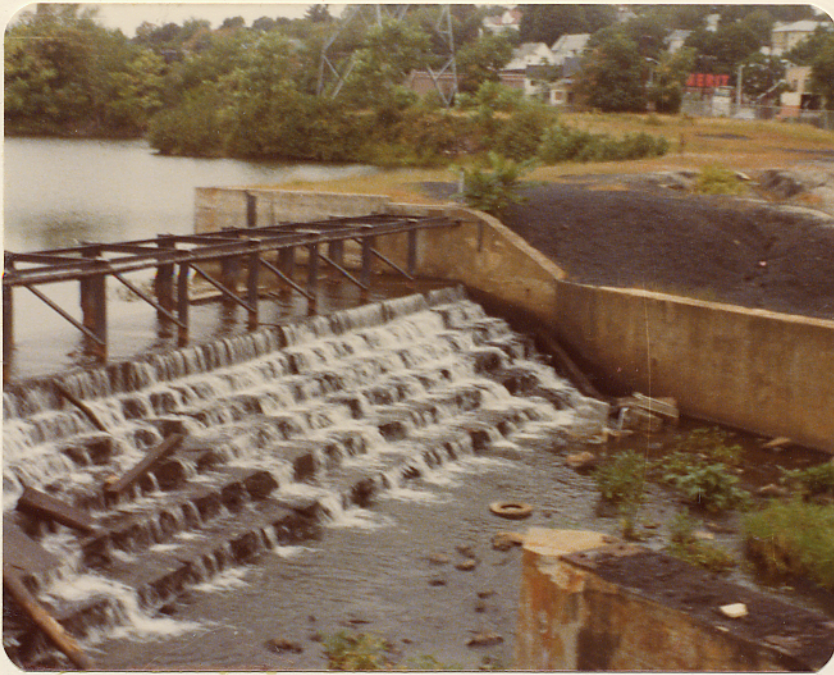
- c. Appurtenant Structures. The spillway is an ungated, 80-foot long, broad crested weir with a stepped stone cascade on the downstream face. A steel frame is mounted on the crest of the spillway and formerly supported a walkway and flashboards. The framework is rusted and

eroded at the base and is an obstruction to flow over the spillway. Wood debris is scattered on the crest and down the cascade. There is minor cracking and staining of the sidewalls.

**NO. 3 VIEW OF SPILLWAY**

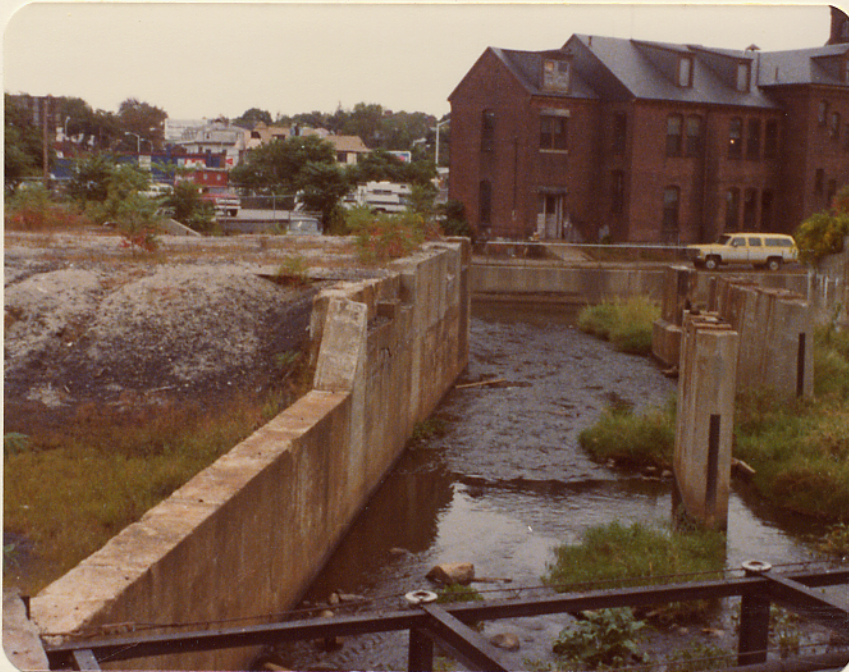
- e. Downstream Channel. Discharge from the spillway flows into a 70-foot wide channel with vertical concrete sidewalls. This channel intersects a second channel at 150 feet downstream, and flow is directed southerly beneath Webster Street. The channel below the spillway contains four concrete piers which formerly supported a railroad trestle. The channel bottom contains scattered debris, mostly at the toe of the spillway. Farther downstream, soil has been deposited in the bottom, and a thick growth of grass covers about half of the channel bottom. The sidewalls are cracked in places and slight staining and spalling occurs along the water line. The channel downstream of the spillway is in good condition, except for a thick growth of grass along the bottom of the southwest sidewall.

**NO. 4 VIEW OF DOWNSTREAM CHANNEL**

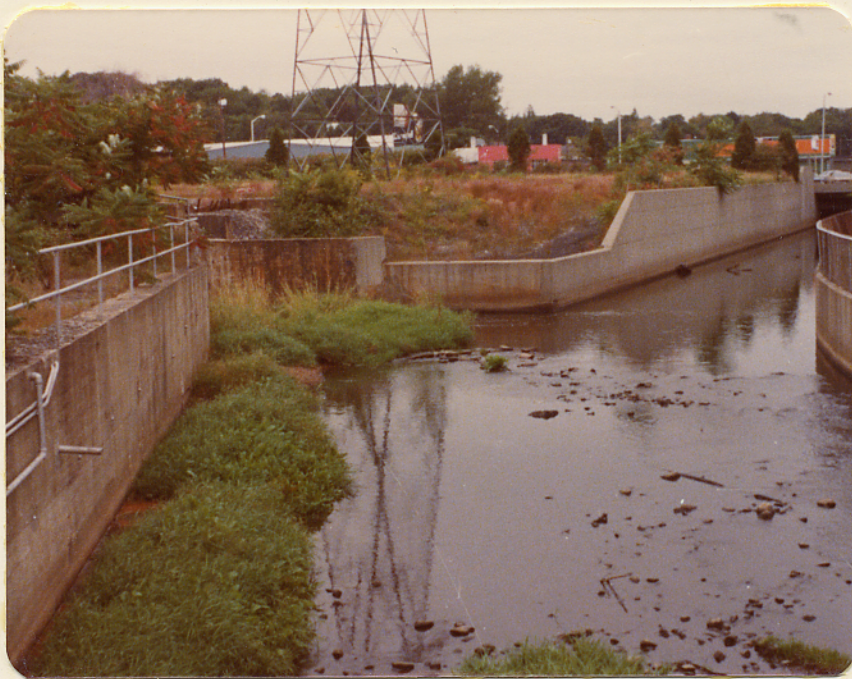
**NO. 5 VIEW OF CONFLUENCE OF DOWNSTREAM  
CHANNEL AND MIDDLE RIVER**

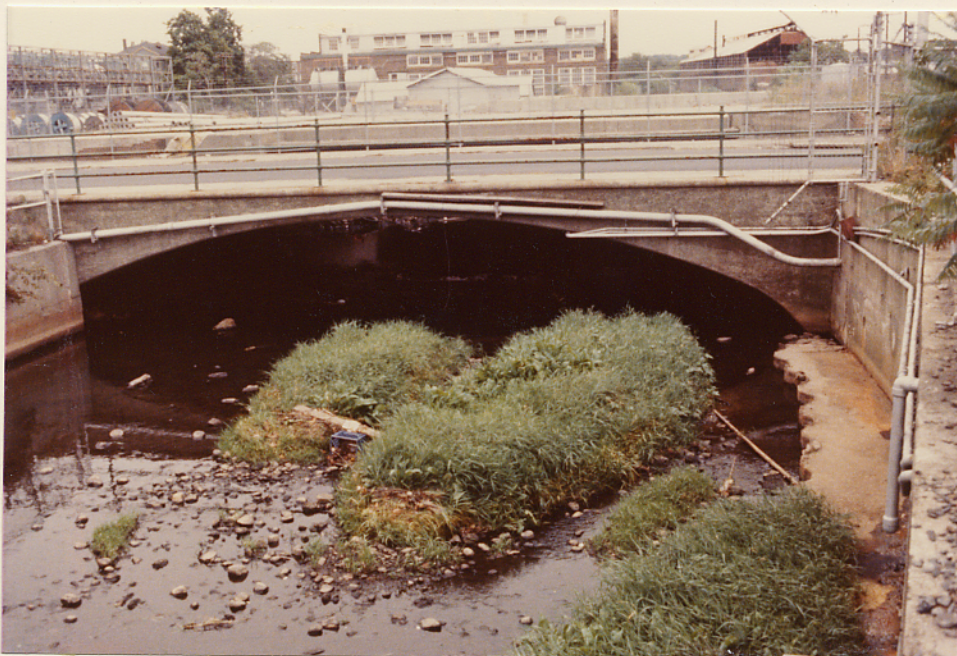
**NO. 6 VIEW OF WEBSTER STREET BRIDGE  
OVER MIDDLE RIVER**
